OPERATION OF A FORCED CIRCULATION, HAYNES ALLOY NO. 25,
MERCURY LOOP TO STUDY CORROSION PRODUCT
SEPARATION TECHNIQUES

By David B. Cooper

Thompson Ramo Wooldridge Inc.

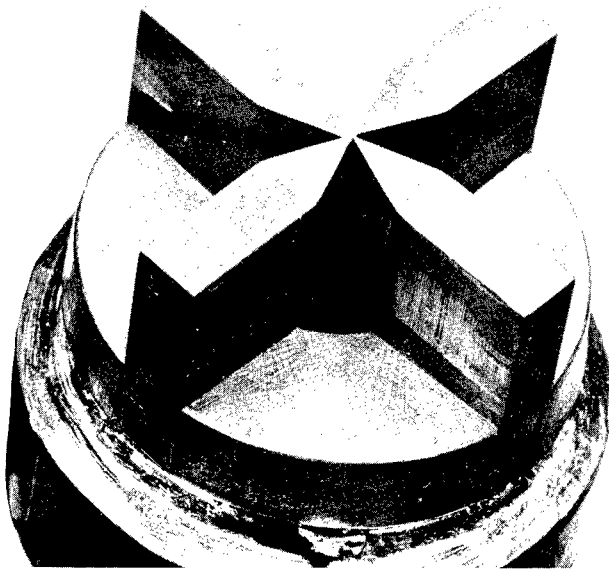
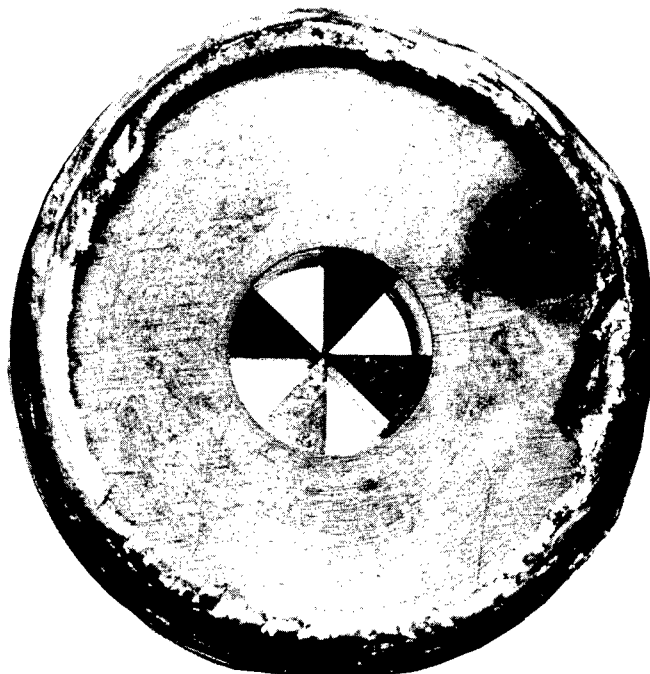
The nozzle was also observed to contain a deposit, as shown in Figure 17. Although there was a small amount of deposition on the inlet side, the majority of the deposit was found on the outlet.

Figure 17. Deposit Found in Loop Nozzle.

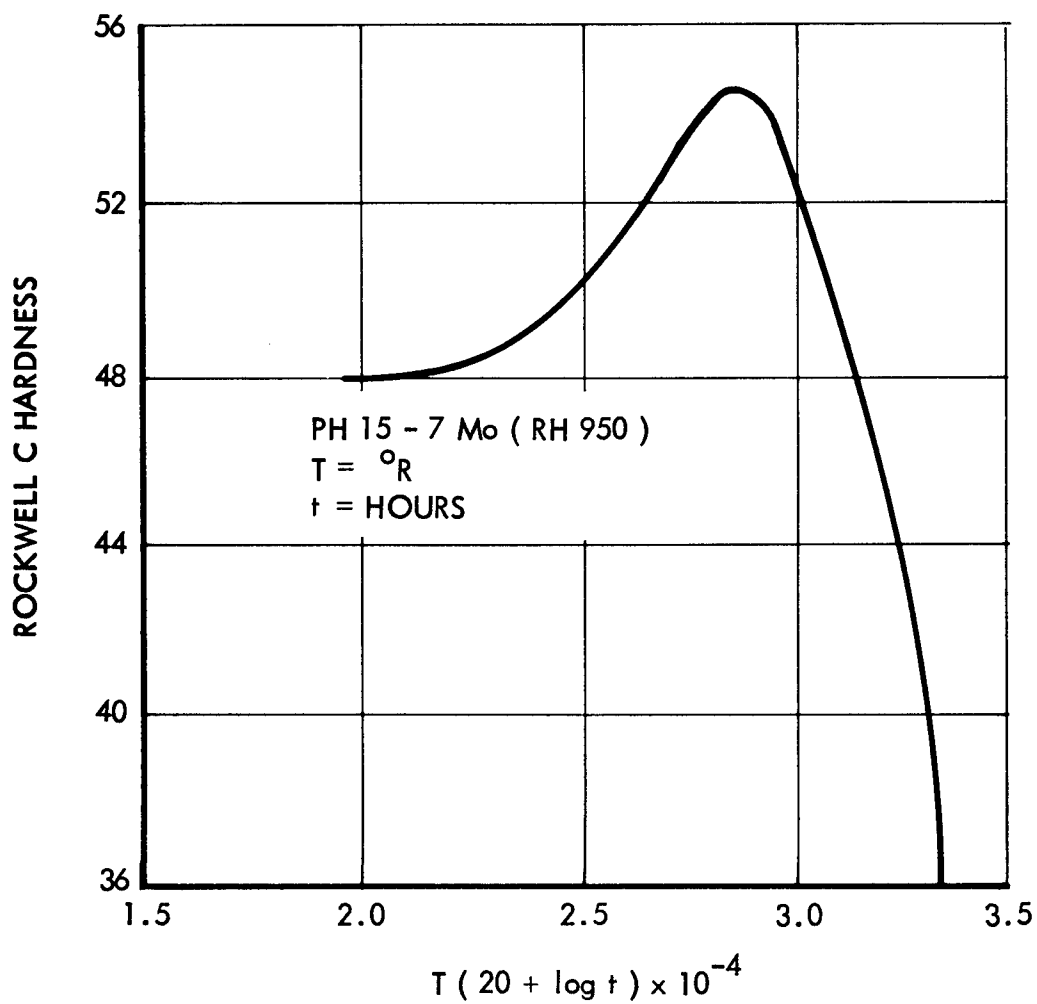
FIGURE 29. MASTER AGING CURVE FOR PH 15-7 Mo
 (CONDITION RH 950) (3)

Unfortunately, when the erosion specimen holder was cut open, the specimens were also cut and a weight change could not be determined. Hardness readings were taken, however, before and after the test and are given in Table 5. These readings indicate that the PH15-7Mo changed very little, while the hardness of the Nivco 10 increased considerably. As a point of interest, the hardness of the PH15-7Mo specimen in the RH 950 condition was used to approximate the average temperature of this specimen during the test, using a master aging curve for this material, Figure 29 (3). Using this method, an average temperature of 875°F was calculated. This compares quite favorably with the 862°F temperature indicated by an immersion thermocouple located at the specimen holder inlet.

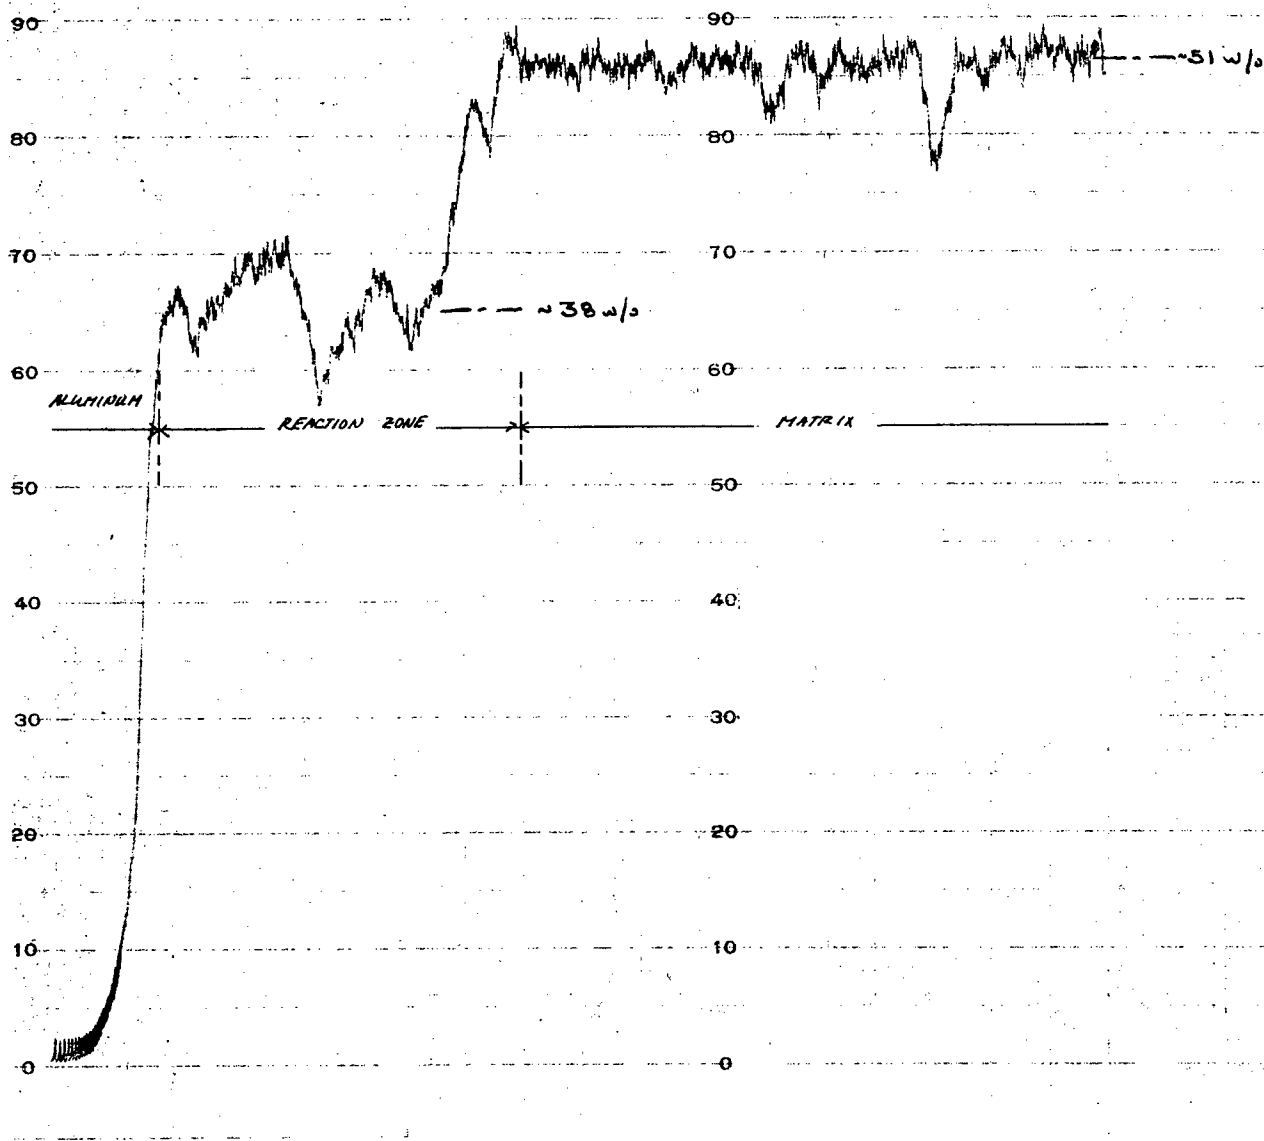
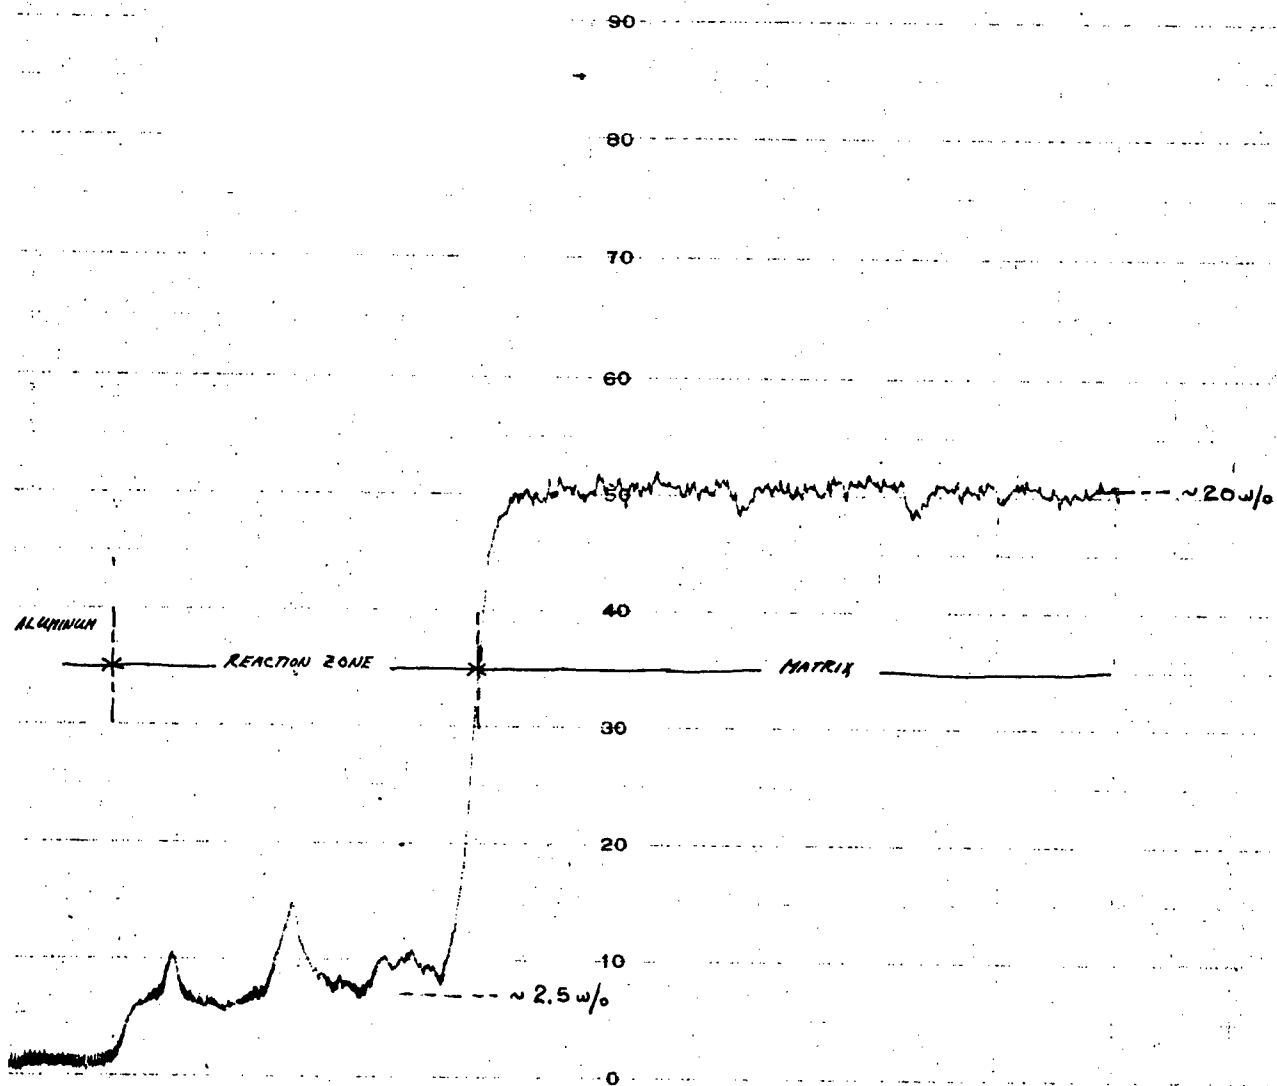
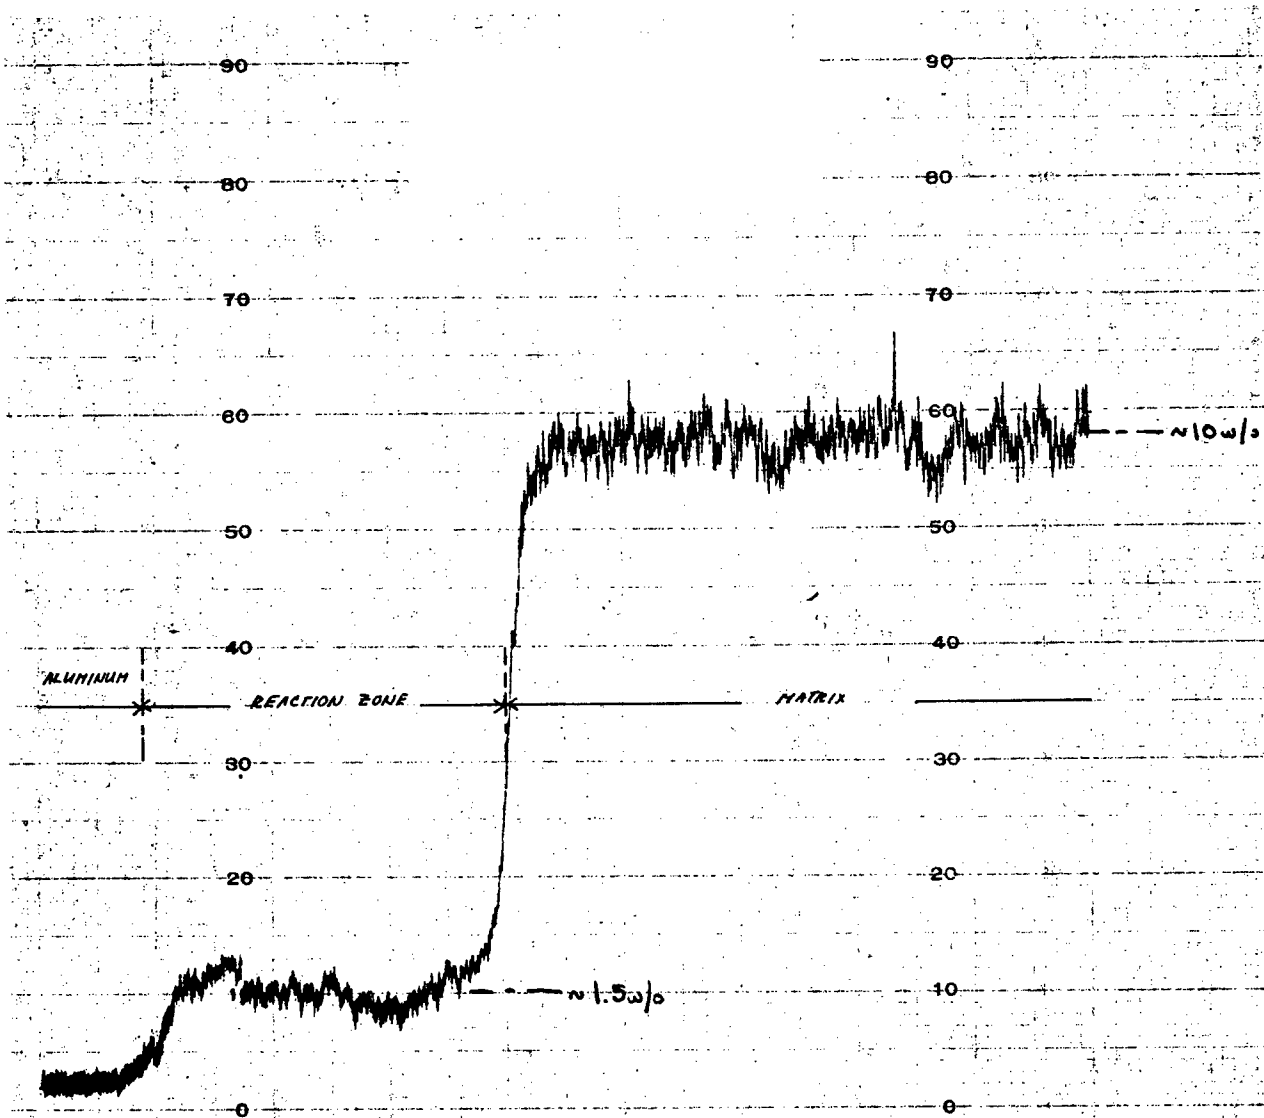
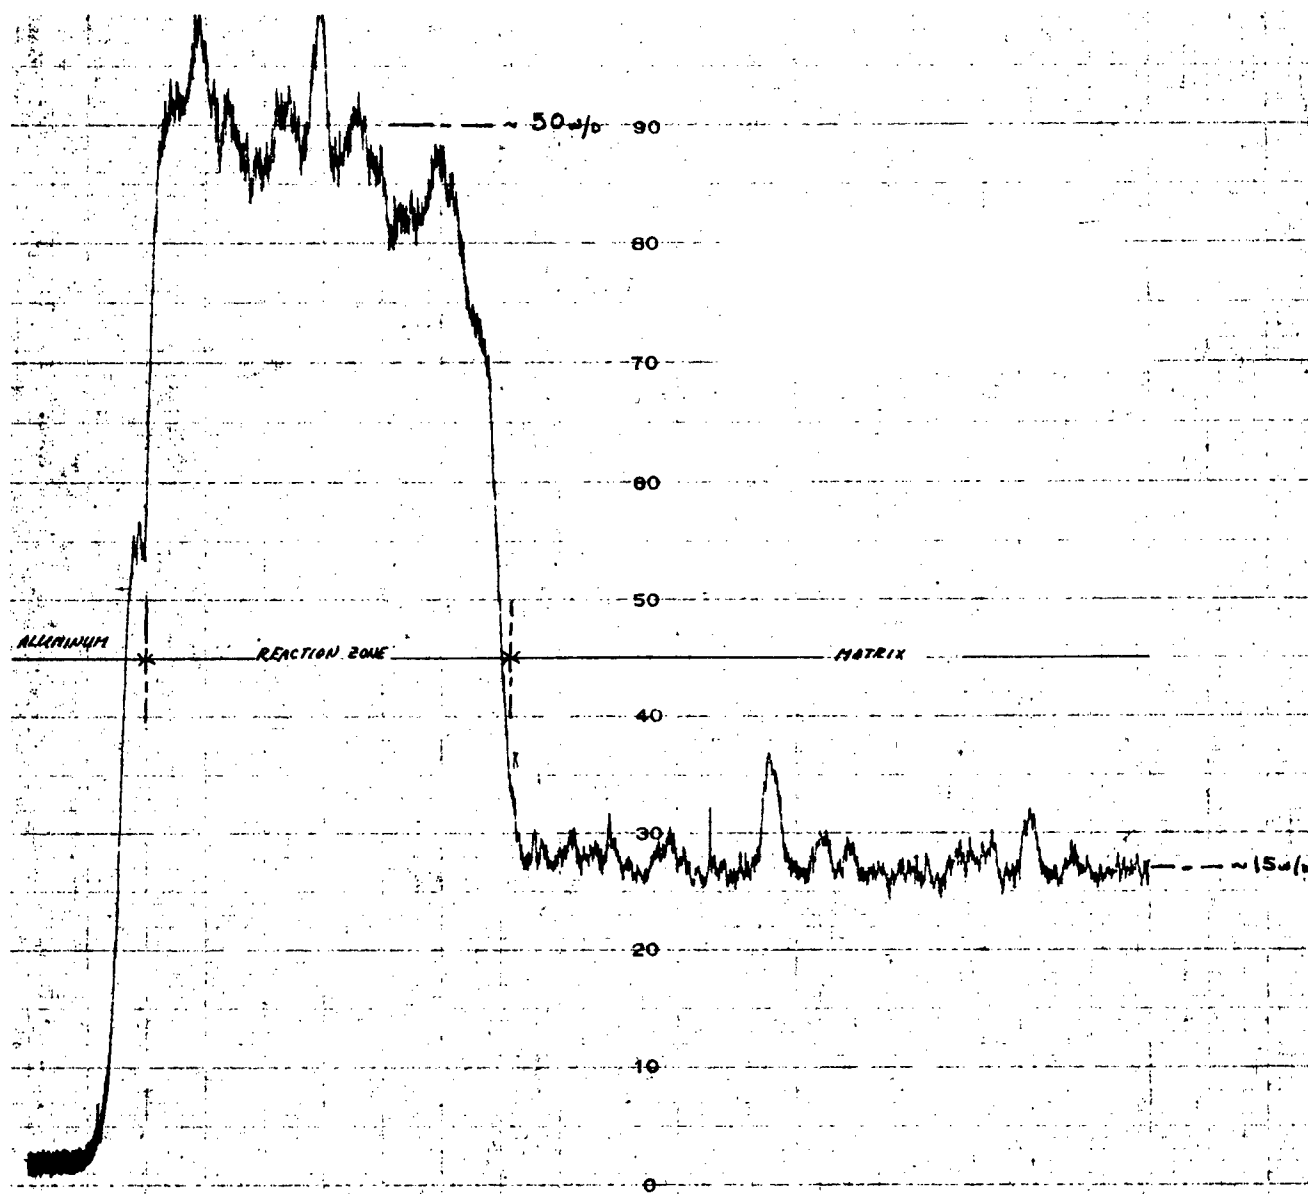
As seen in Figures 31 through 34, the electron beam microanalysis on the pre-heater outlet specimen (see Figure 20b) revealed a leached layer with an abrupt concentration discontinuity approximately 40 to 45 microns from the surface. The corrosion layer was found to be enriched in tungsten and depleted in nickel, chromium, and cobalt. Zirconium was found in the matrix as tungsten-zirconium carbides and comprised less than 0.05 percent. The zirconium concentration rose to 0.05 to 0.08 percent in the corrosion layer; however, the background intensity also rose as a result of the increased tungsten content. The titanium and columbium concentrations were consistently less than 0.05 percent.

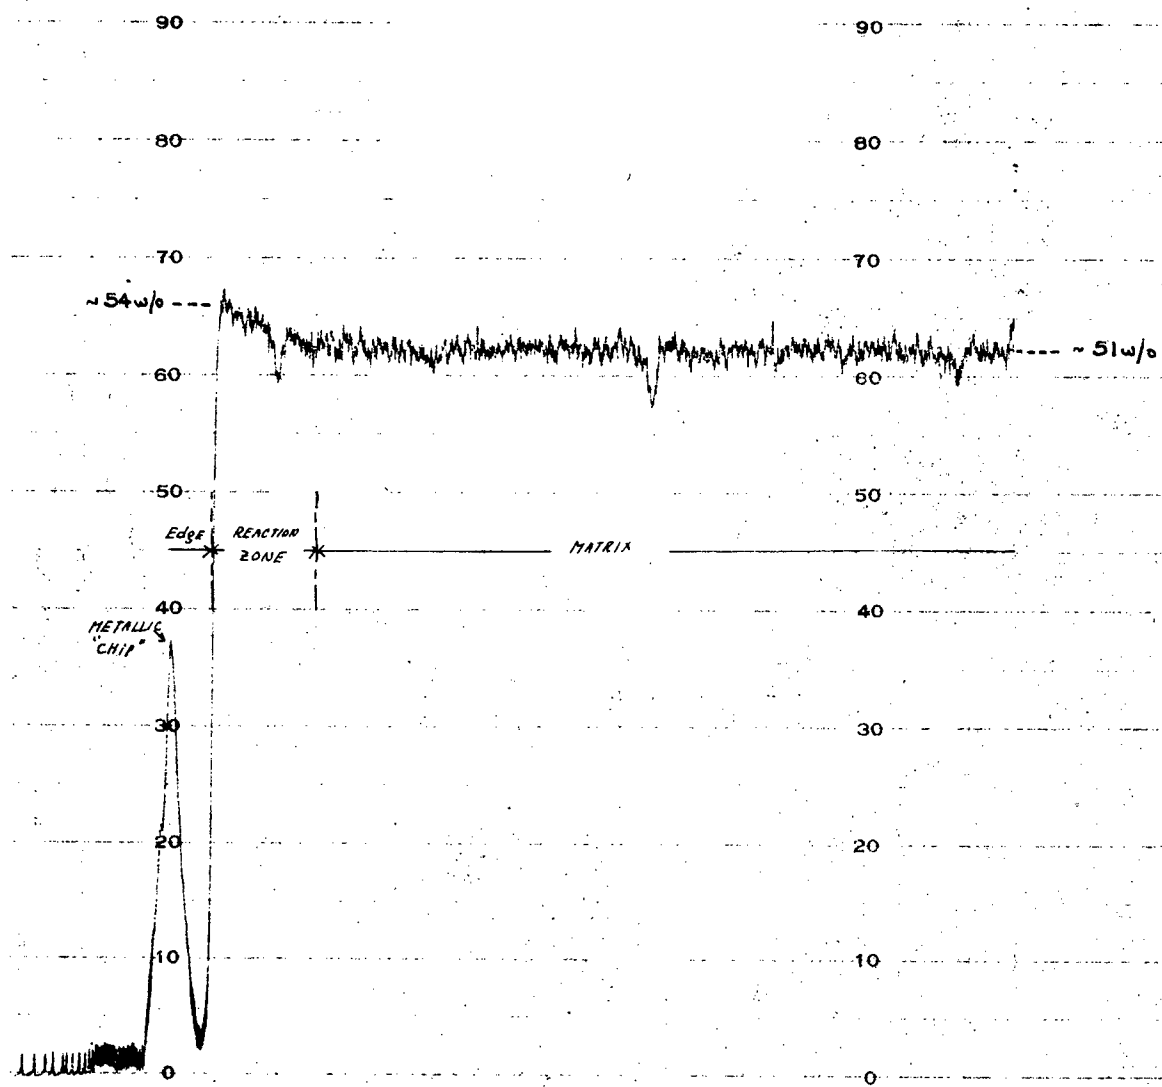
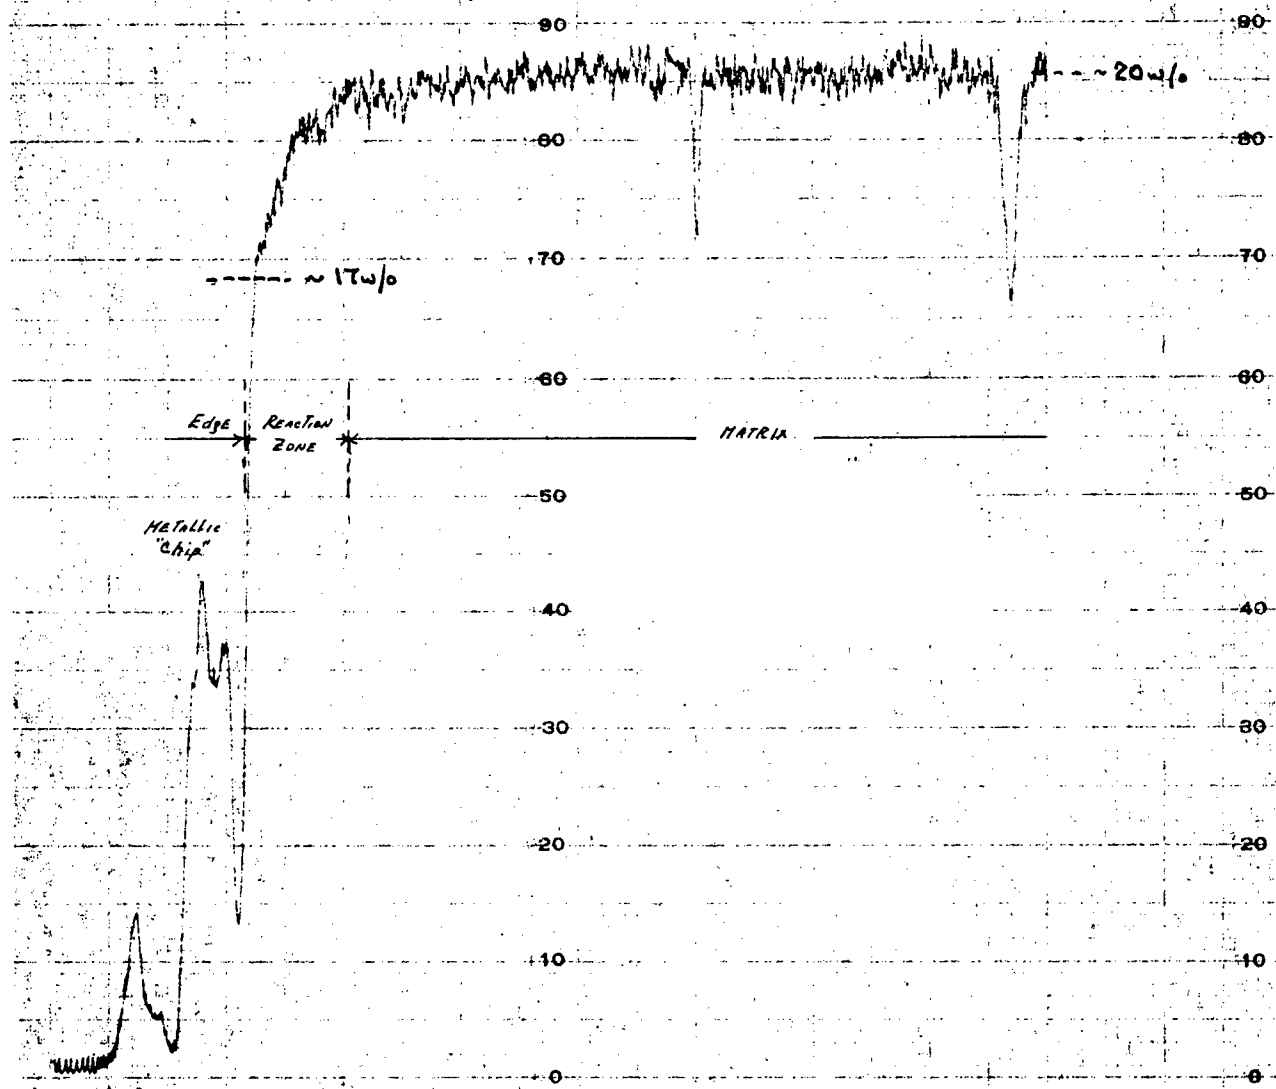
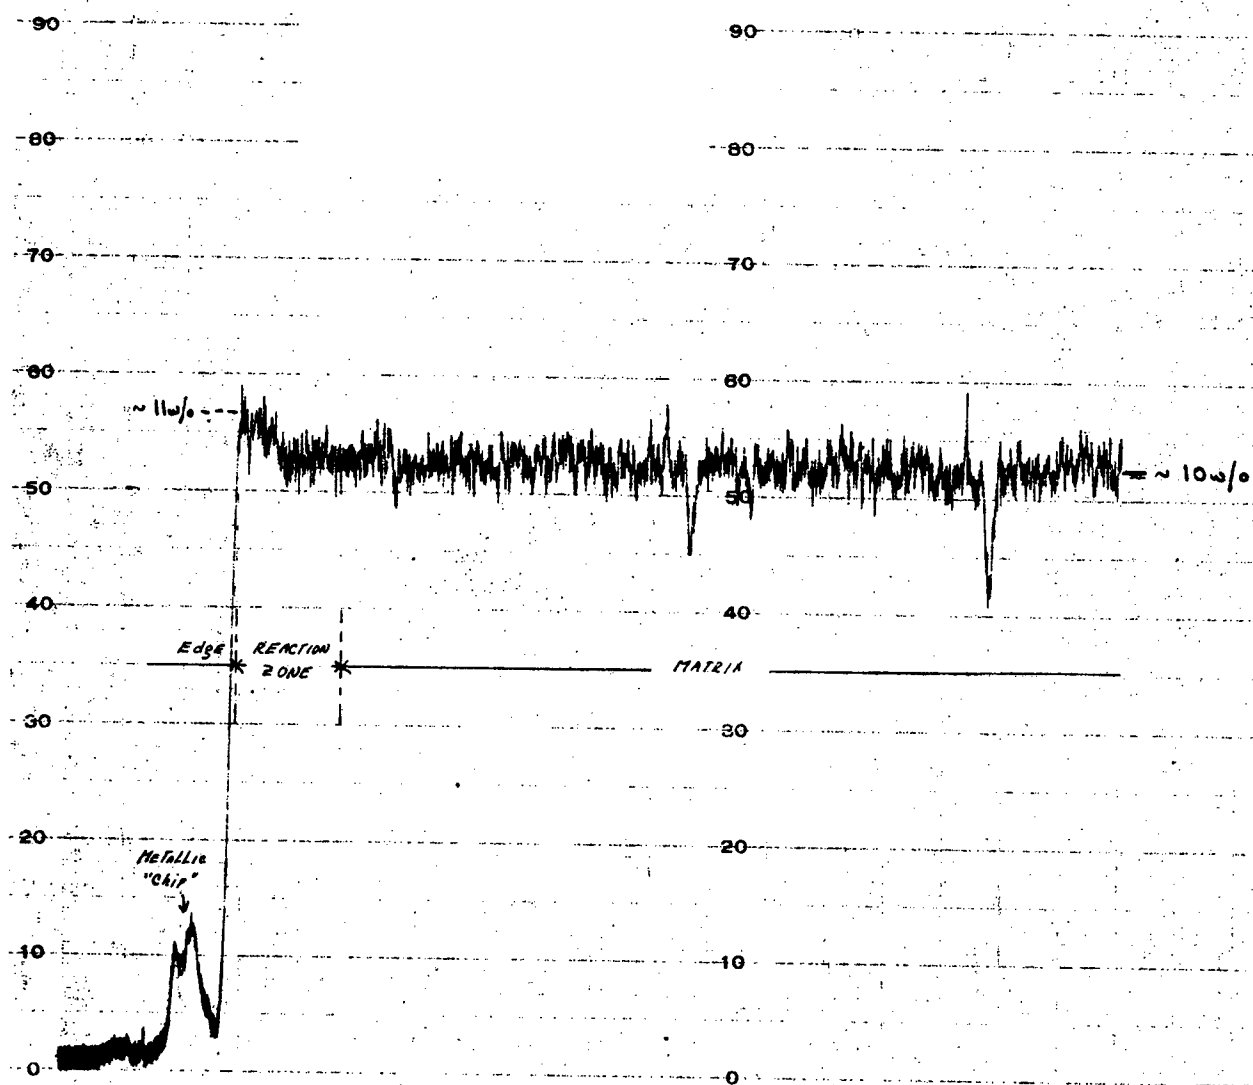
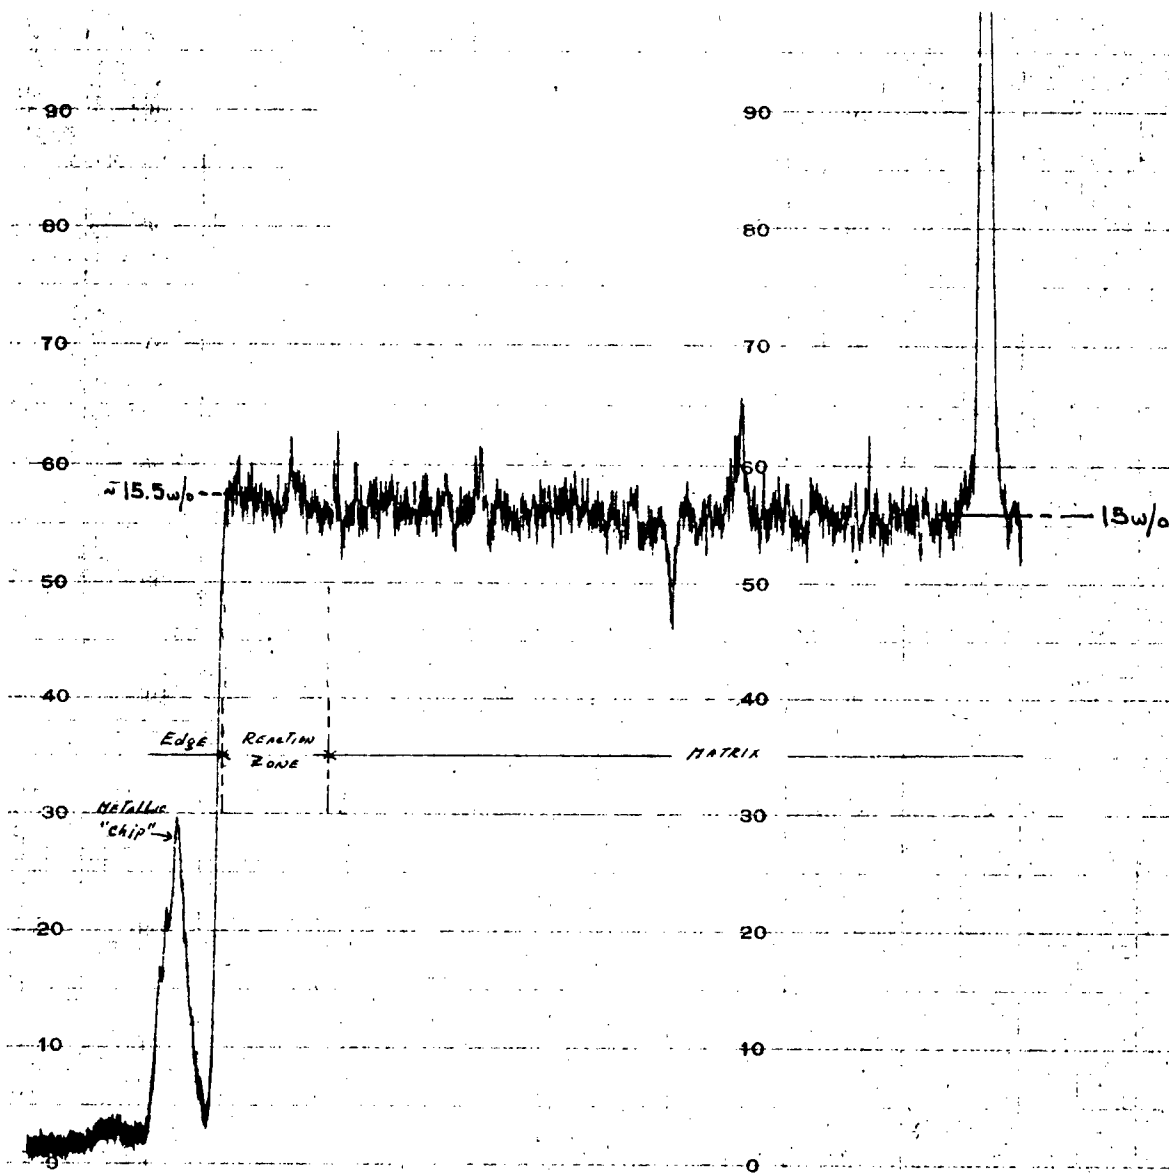
The condenser outlet specimen (see Figure 22d) revealed no visible evidence of a surface chemistry change. However, the concentration distributions (Figures 35 through 38) showed the presence of a slowly varying gradient to a depth of 25 to 30 microns. Cobalt, nickel, and tungsten showed an increase at the I.D. surface of the specimen, while chromium was found to be depleted. A small metallic chip, partially buried in the mount material, was included in the traverse. This chip was the only one noted in the area selected for analysis and is considered insignificant. Except for some zirconium in the matrix tungsten-zirconium carbides, the zirconium, titanium, and columbium concentrations were consistently less than 0.05 percent.

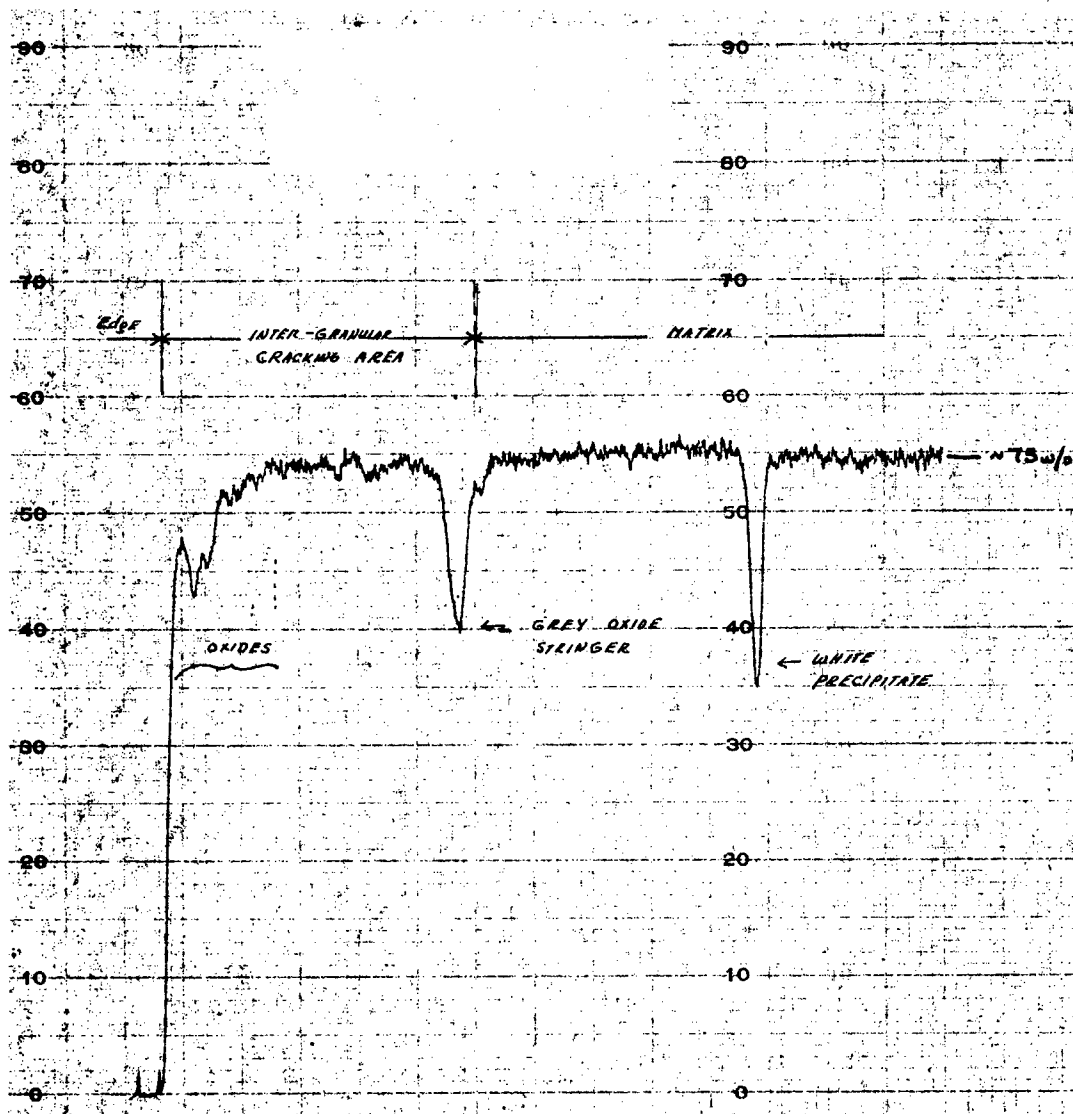
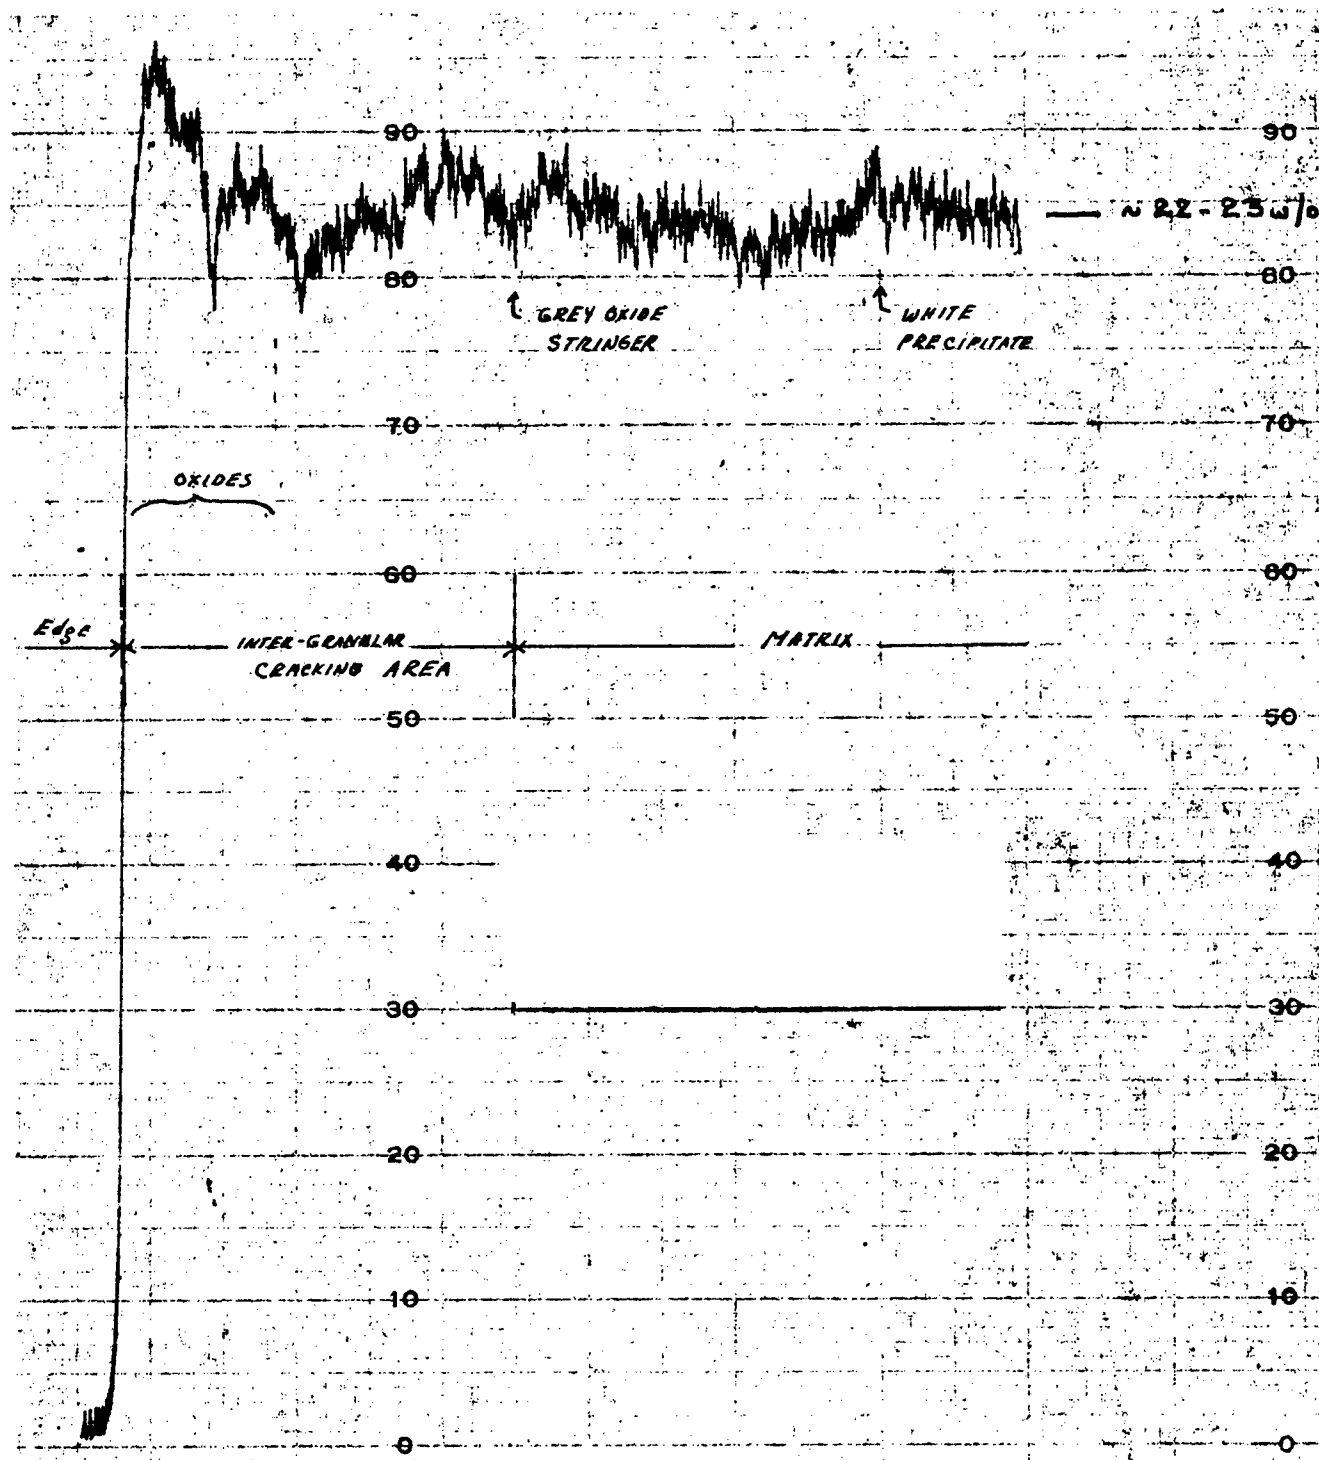
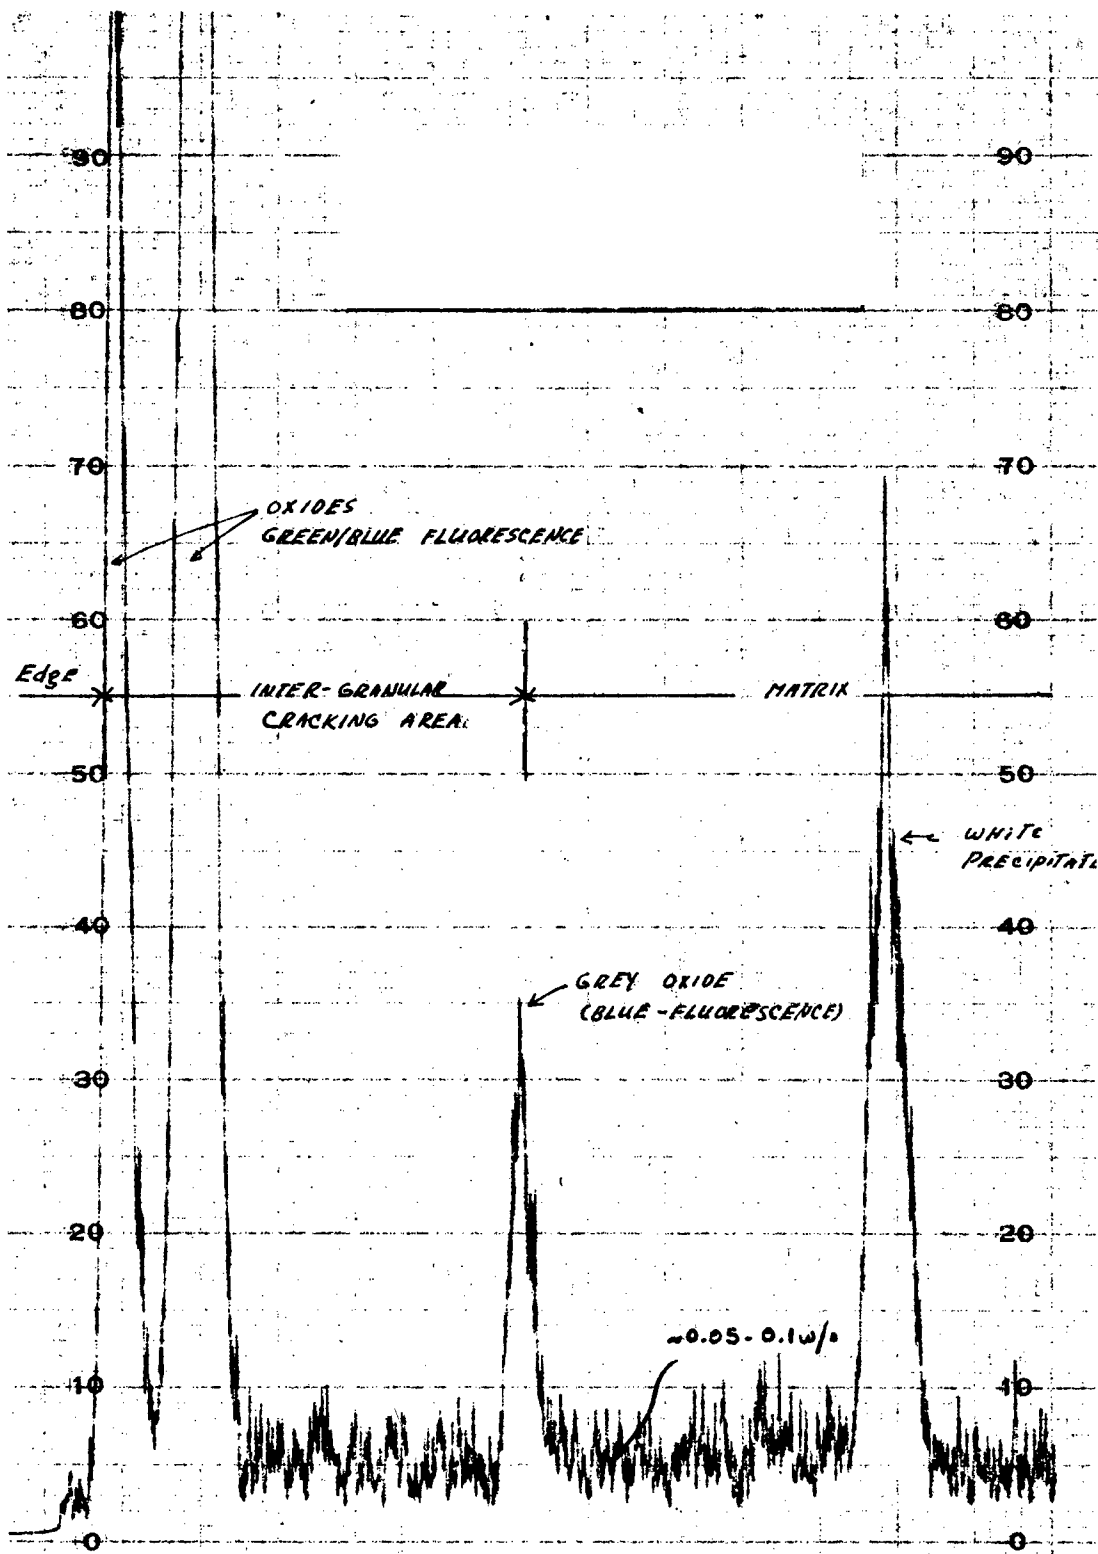
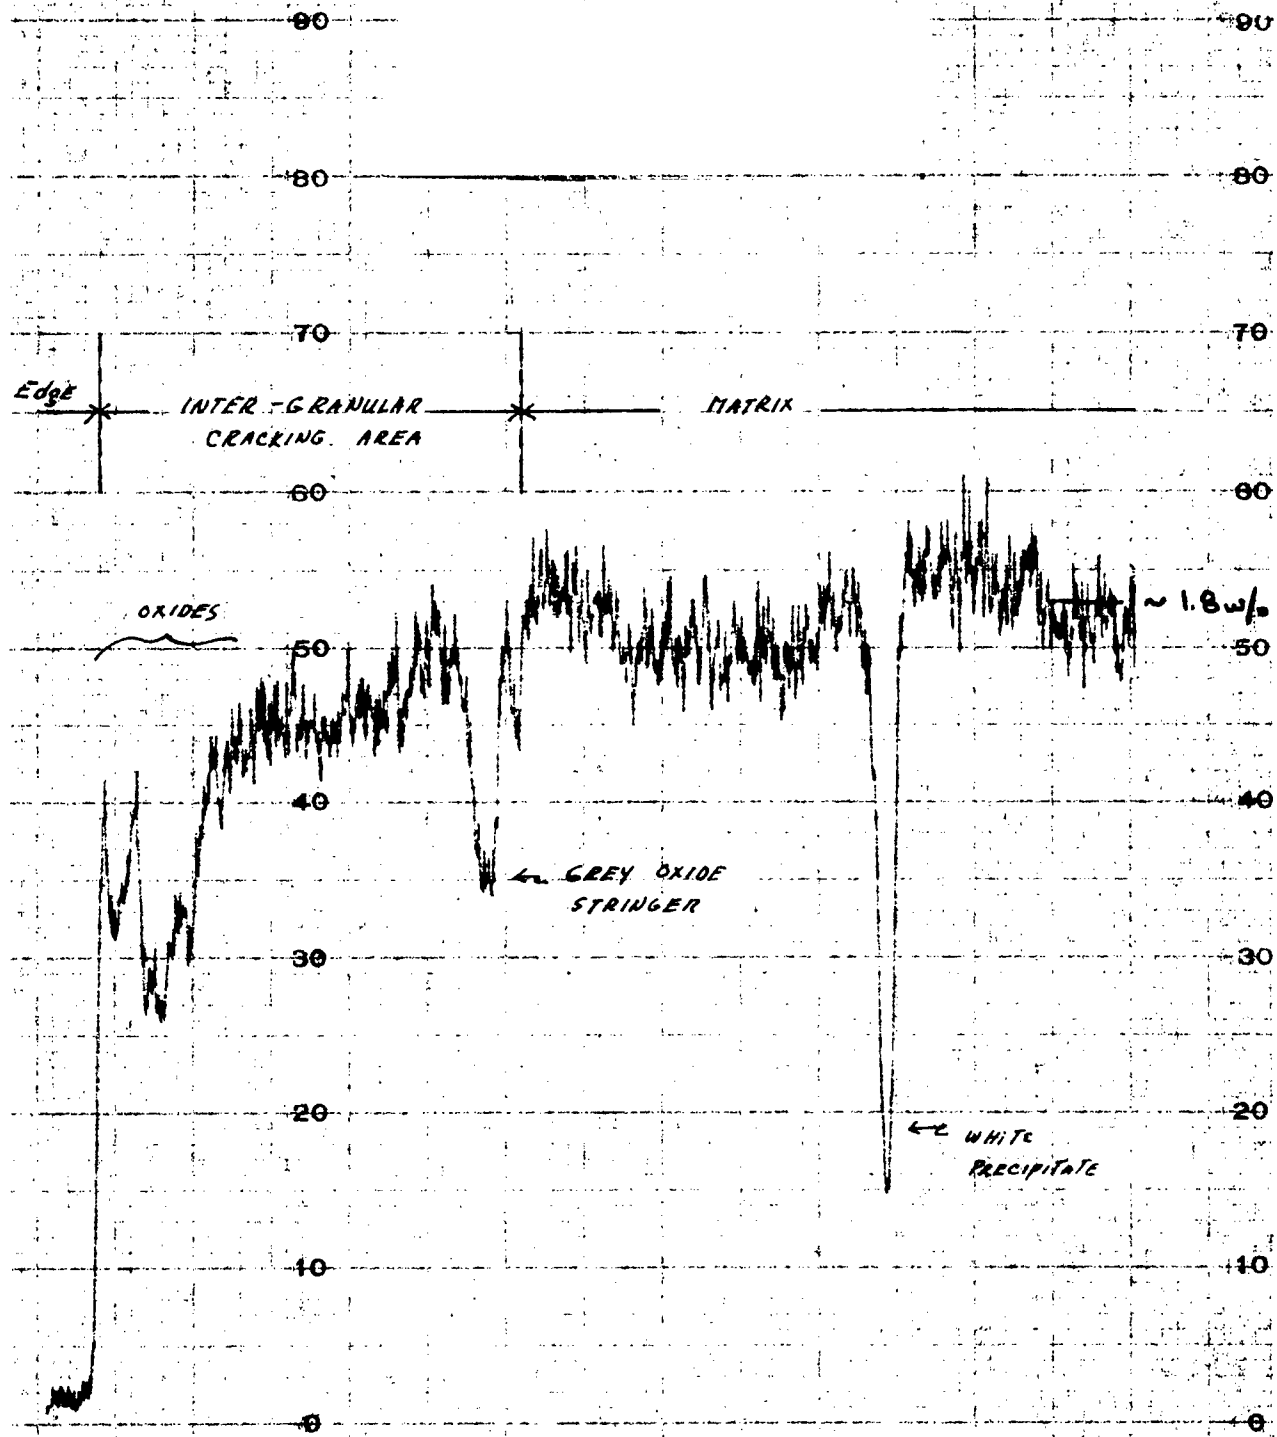
Examination of the nozzle throat specimen (see Figure 27b) revealed a surface zone of intergranular precipitation extending to a depth of approximately 70 microns. A series of large gray precipitates near the base metal-end of the surface zone were also noted. The gray phases and oxides were found to be zirconium oxides that appeared to also contain some nickel in solution. These phases were identified as oxides since they yielded a visible fluorescence when struck by the electron beam. This fluorescence is typical of the presence of combined oxygen. The composition of the metal matrix surrounding the oxides was found to be essentially the same as the base metal. The concentration distributions for chromium and tungsten were consistent at less than 0.05 percent.
